A49 Spurstow

Petition Submission Report

February 2017

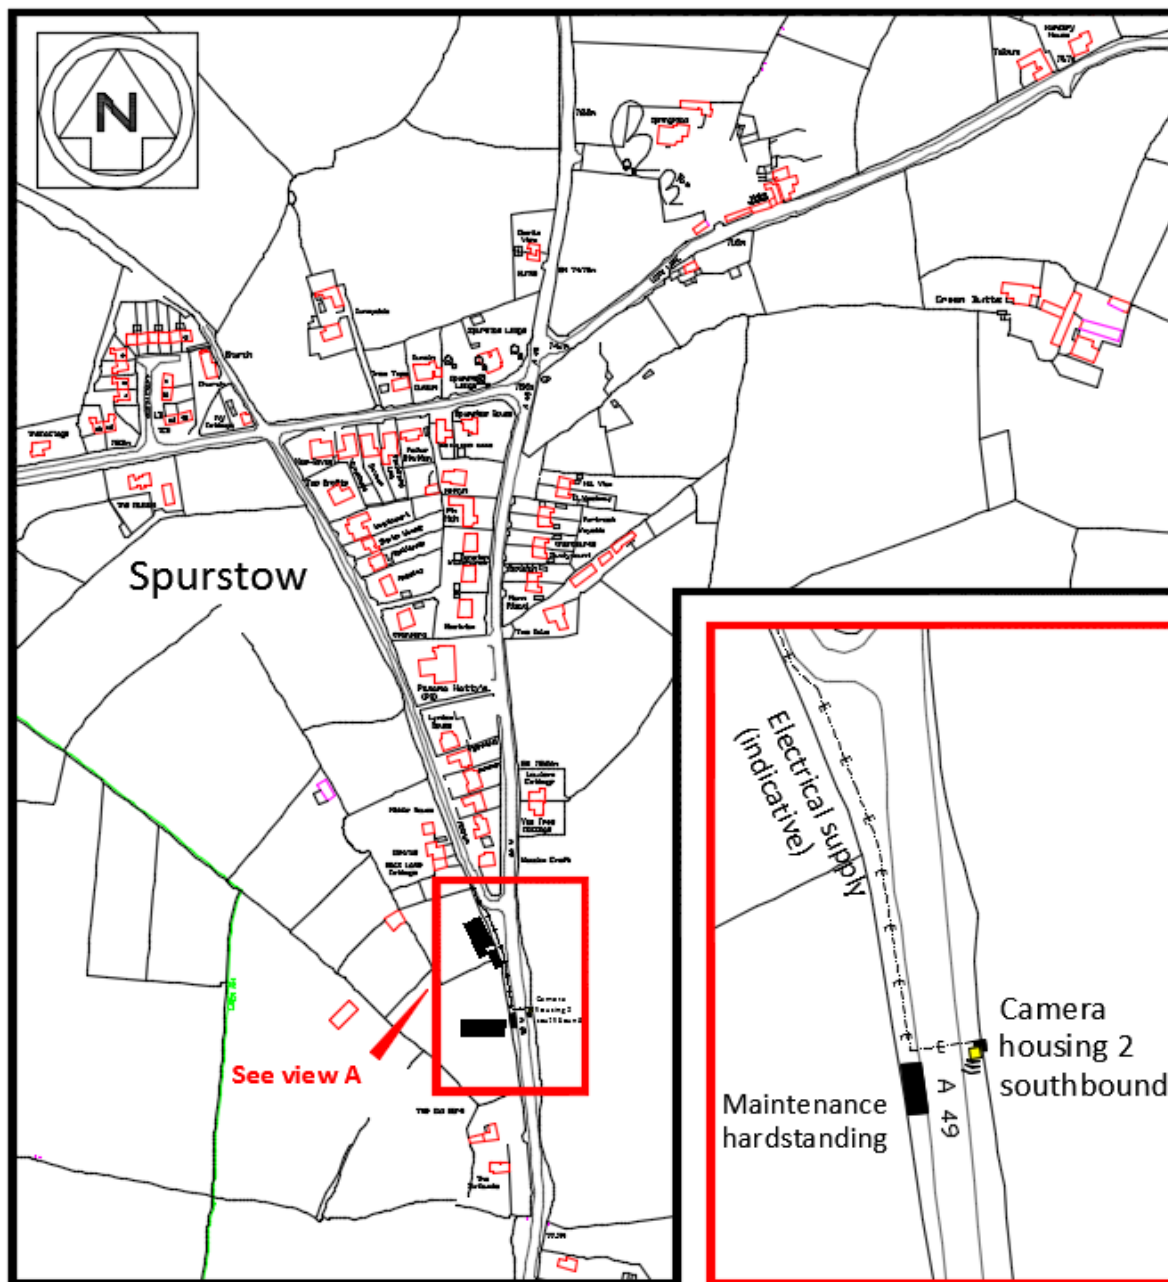
At present there is a safety camera within the existing 40mph speed limit. It is located to the south of Back Lane (also known as Nursery Lane), facing south. (see below).

Existing safety camera location

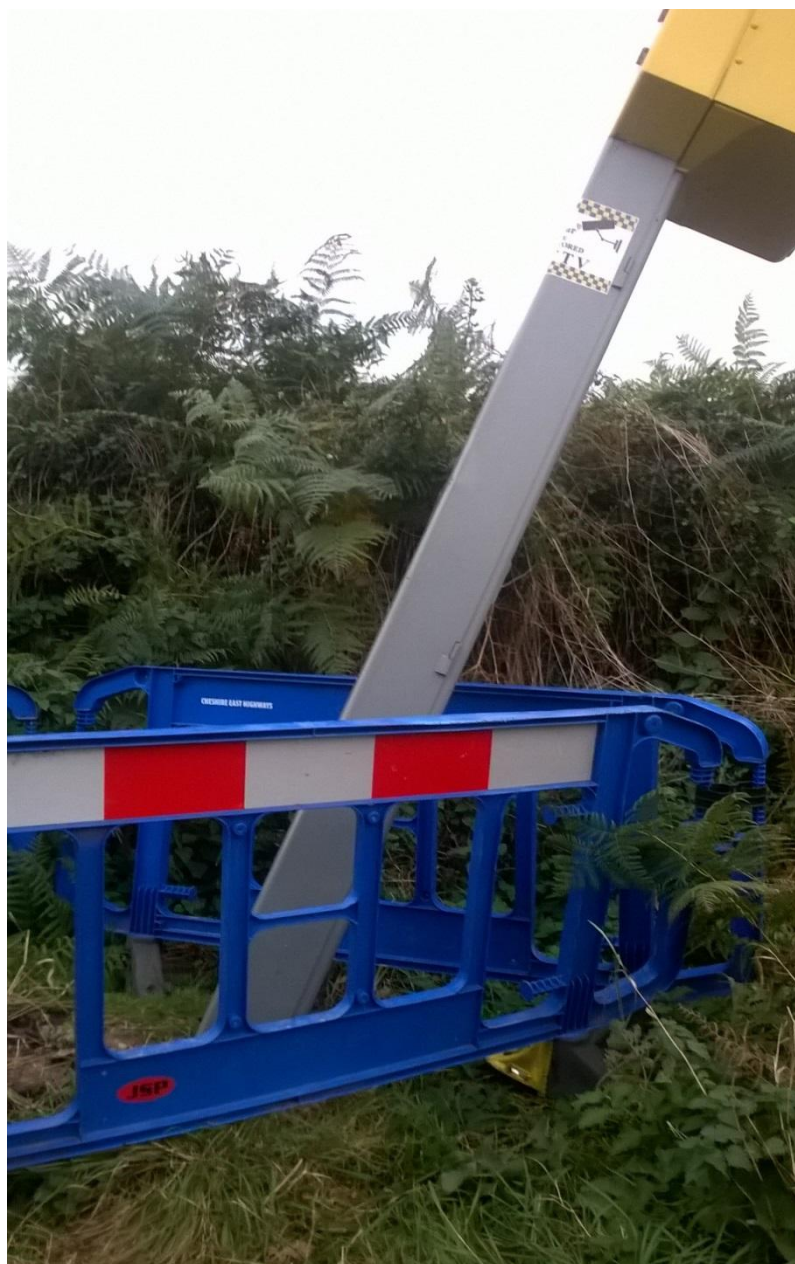
The camera has been subject to vandalism on two separate occasions and is currently out of action. It has been pushed over from the top of the pole and is presently leaning and requires attention in order for it to become operational again.

Vandalised safety camera

An estimate of £10,618.80 has been received from the safety camera supplier to relocate the camera. It is recommended that the camera is re-sited to a location close to Panama Hatty's, subject to a survey and the presence of statutory undertaker services. This location is closer to the residential properties and is therefore less likely to future vandalism. It would also have a positive effect on the adherence to the speed limit in the residential core of Spurstow.

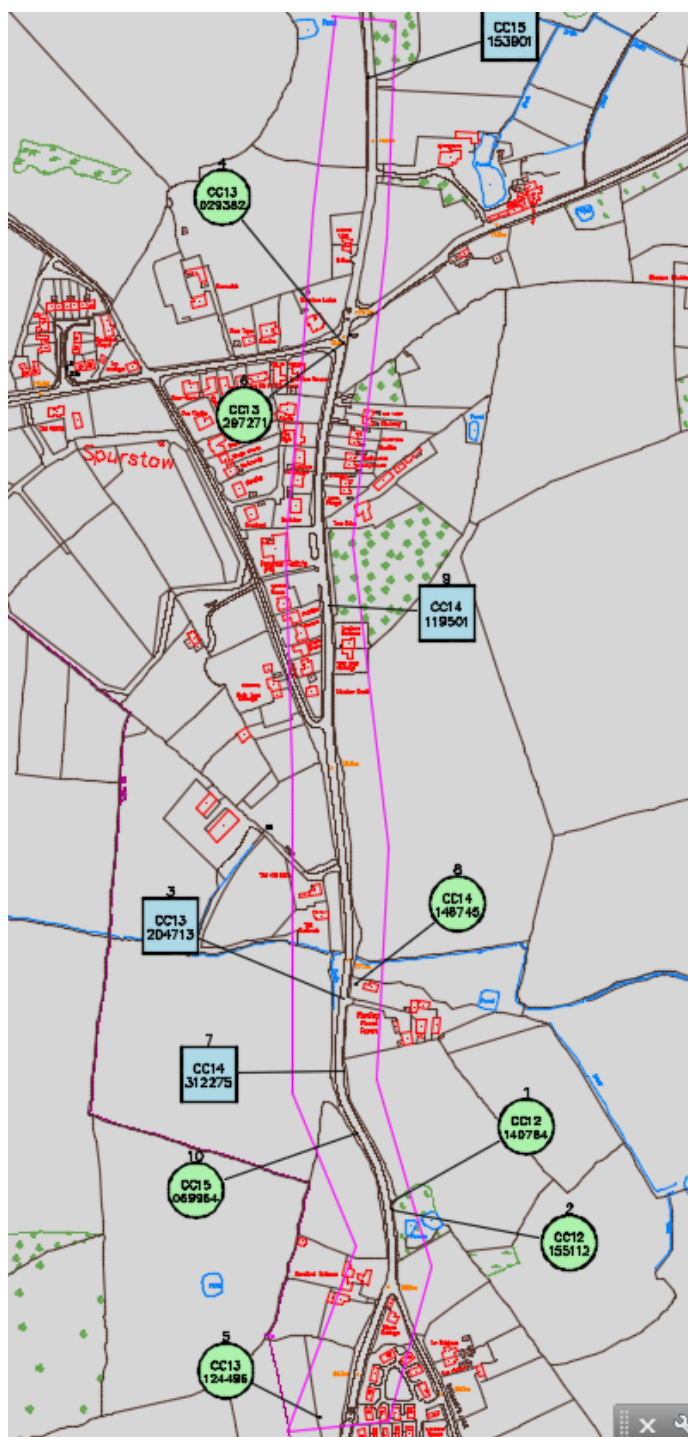
Injury collision locations

The junctions at Badcock's Lane and at Peckforton Hall Lane/Long Lane were of particular concern to local residents, who referred to them as "accident blackspots". For the latest 5 year collision data period, no injury collisions were reported at the Badcock's Lane junction. There were two slight injury collisions reported at the Peckforton Hall Lane/Long Lane junction, both in 2013 and prior to the introduction of the current 40mph speed limit. The two junctions do not therefore highlight any issues regarding safety.

The eleven collisions are spread over the length of the A49 through Spurstow, as can be seen on page 7, with six occurring prior to the introduction of the existing 40mph speed limit (Collisions 1 to 6 on page 7). Since the 40mph speed limit was introduced on 29th November 2013, there have been five injury collisions reported, three of which were serious and two slight. The contributory factors are recorded as;

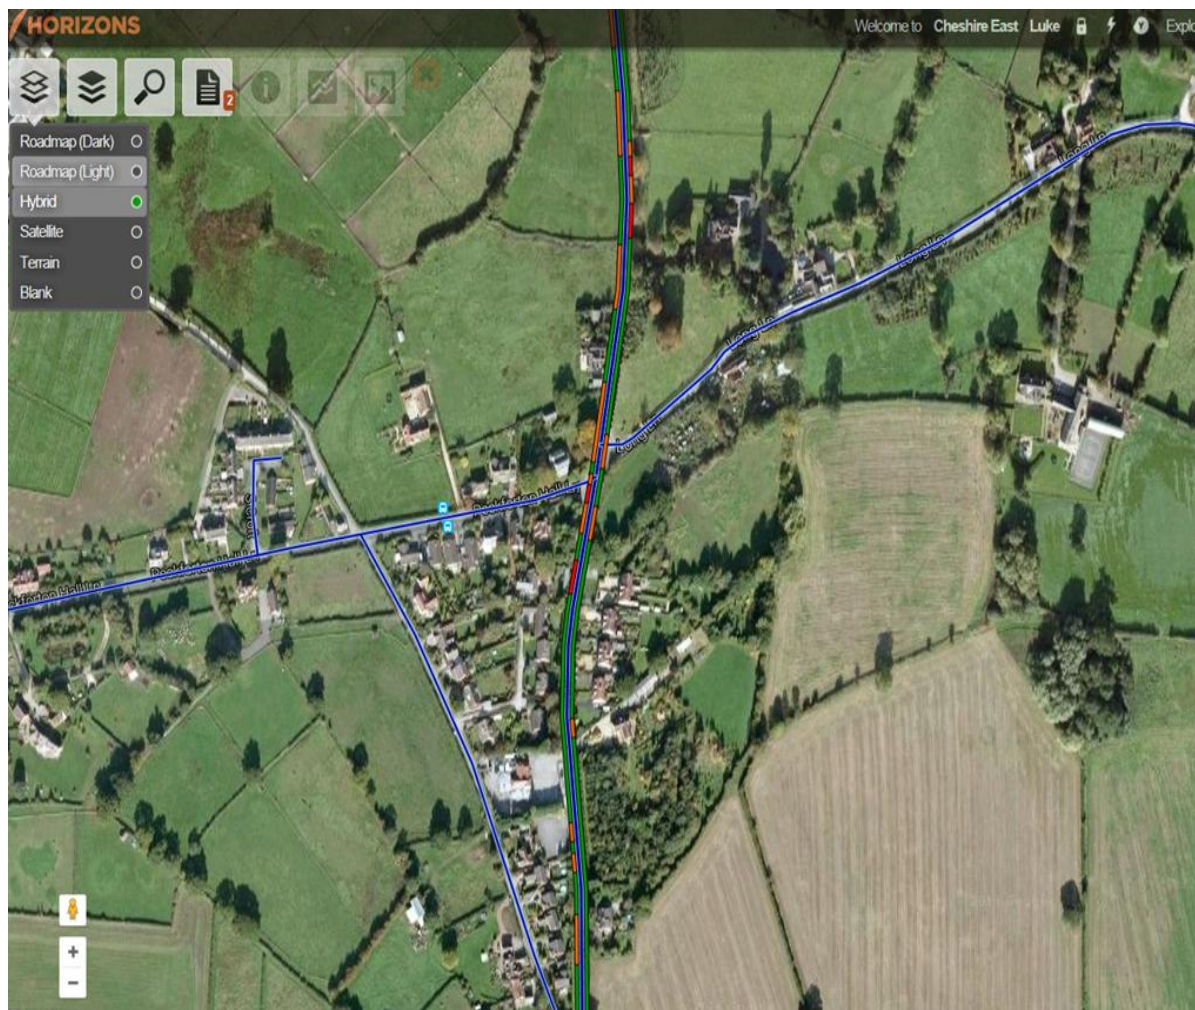
A road surface condition survey was carried out on the A49 through Spurstow in May 2016. The overall condition was recorded as good (shown in green below).

Four of the five injury collisions that have taken place since the 40mph speed limit was introduced have a contributory factor of “Slippery road due to weather” and occurred on a wet road surface in the rain. Consideration could be given for grip fibre/surface dressing treatment.
